CENTRAL INTELLIGENCE AGENCY

INFORMATION REPORT

Tank Repair Shops in East Germany

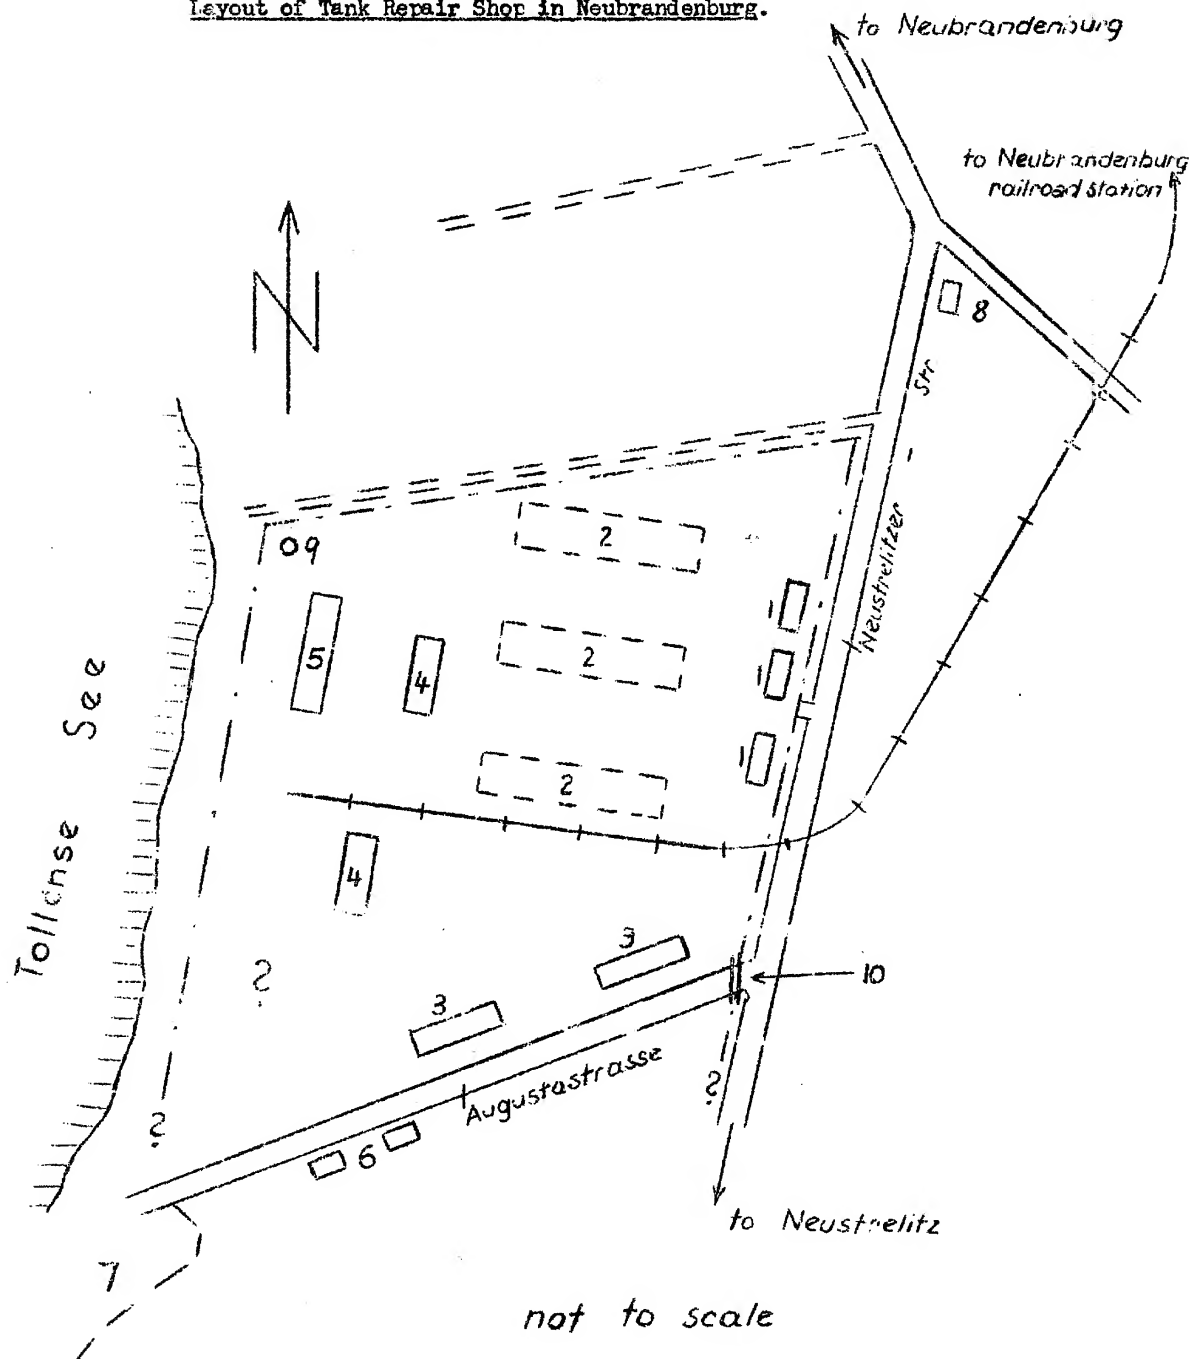
Annex 1

Layout of Tank Repair Shop in Neubrandenburg.

1. Presumably administrative buildings, permanent two story structures,
2. From 20 to 30 low wooden buildings,
3. Permanent two-story buildings,
4. Permanent workshops,
5. Tank repair shop,
6. Private houses vacated by the civilian population,
7. Augustabad,
8. Hotel and HC depot,
9. Observation tower,
10. Guarded roadblock.

1. In March 1953, [] a VP tank and motor vehicle repair shop on Augustabad Strasse in Neubrandenburg. A total of 300 VPs and 50 Soviet soldiers were seen there. Only the VP section of the installation was guarded. ¹

- 25X1 [REDACTED] 12. In February 1953, [REDACTED] the tank repair shop was still located at the Fibre Plant in Fuerstenberg.
- 25X1 1. [REDACTED] Comment. The establishment in Neubrandenburg of a KVP tank repair shop was also reported [REDACTED] For layout sketch of the installation, see Annex [REDACTED].

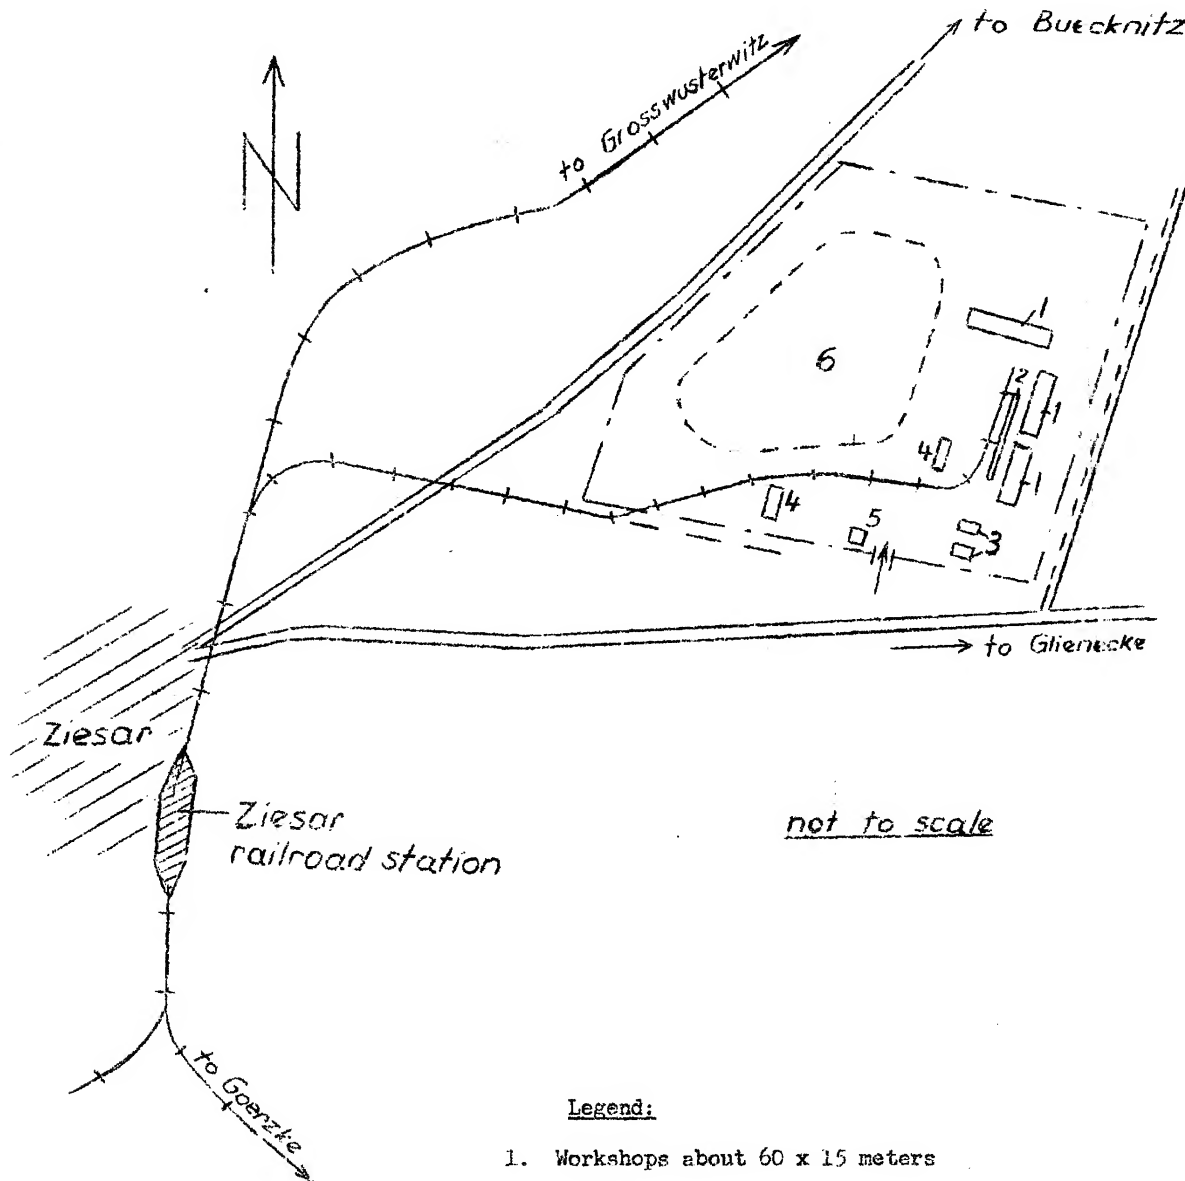
Layout of Tank Repair Shop at Ziesar.

1. Workshops about 60 x 15 meters
2. Loading ramp
3. Probably quartering buildings
4. Temporary single-story buildings
5. Guardhouse
6. Area with an undetermined number of buildings.

6. In 1945, the German tank ordnance depot located near Ziesar, south of the road to Buecknitz was destroyed. By 1951, the installation had been rebuilt and taken over by the Soviets. At present, a Soviet tank repair shop and a tank spare parts depot are located at the installation, which consists of four or five large storage sheds and an administration building. ⁴

- 25X1 4. [REDACTED] Comment. For layout sketch of the installation, see Annex 2. A tank spare parts depot and a motor vehicle repair shop, [REDACTED] are located 25X1 in Ziesar. Both installations belong to the 3d Shock Army.

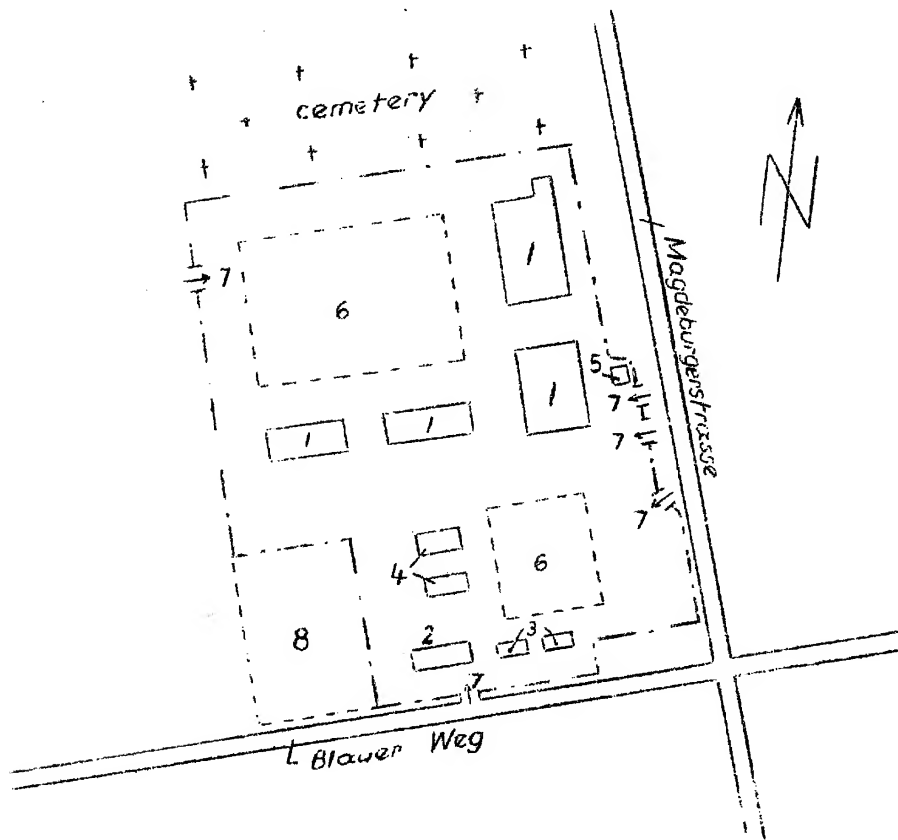
Tank Repair Shop in Schoenebeck.

1. Workshops
2. Kitchen and Messhall
3. Dwelling houses
4. Underground bunkers
5. Guardhouse
6. No details available on the buildings in this area
7. Gates
8. Scrap dump.

10. In February, [REDACTED] a Soviet tank repair shop in the area of the former Sprengstoffabrik (Explosives Plant) in Schoenebeck west of Magdeburger Strasse and north of Blauer Steinweg. Tanks undergoing trial runs were frequently seen in the adjacent area. In early February, [REDACTED] a train which carried four T-34/85 tanks [REDACTED] at Schoenebeck railroad station.
